# VEHICLE INSPECTION REPORT

**PE63MZU**

## Daf LF 45.140

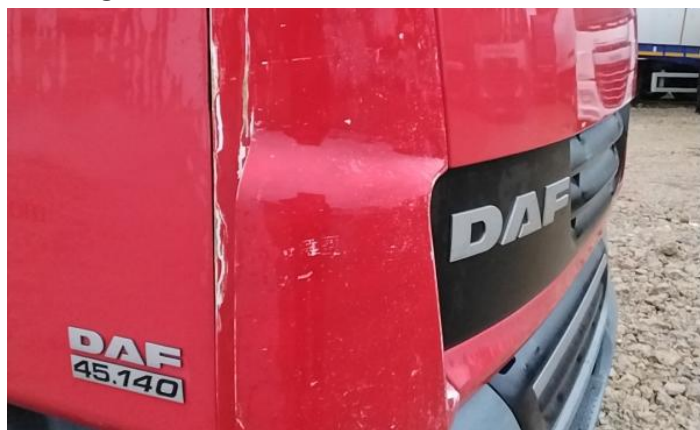
1: Wing osf  
Scratched  
Over 25mm Thru Paint

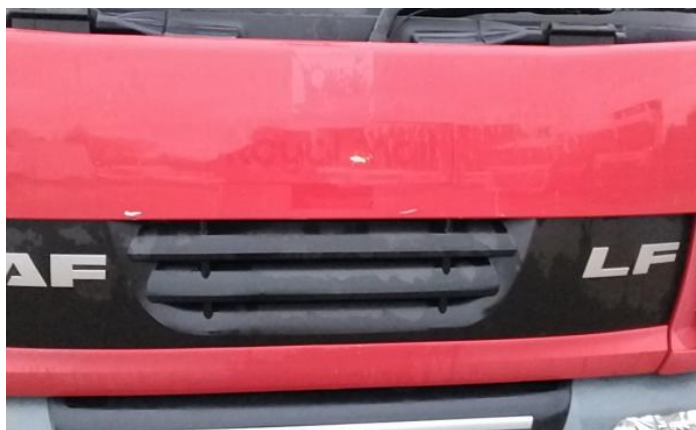
2: Bonnet  
Scratched  
Over 25mm Thru Paint

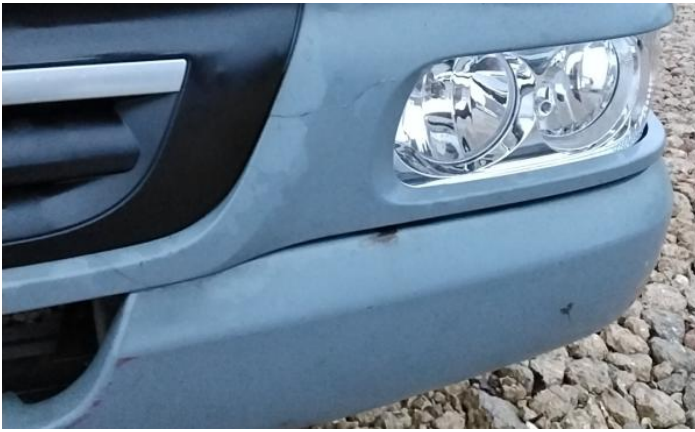
3: Fog Lamp Surround nsf  
Broken  
Replace

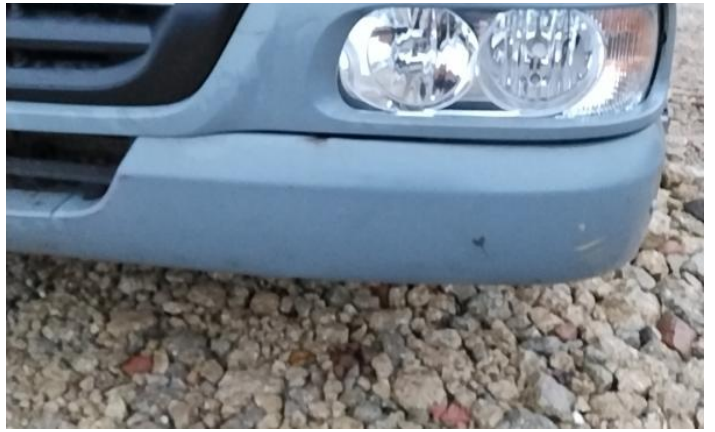
4: Bumper Front  
Rusted  
Over 5mm

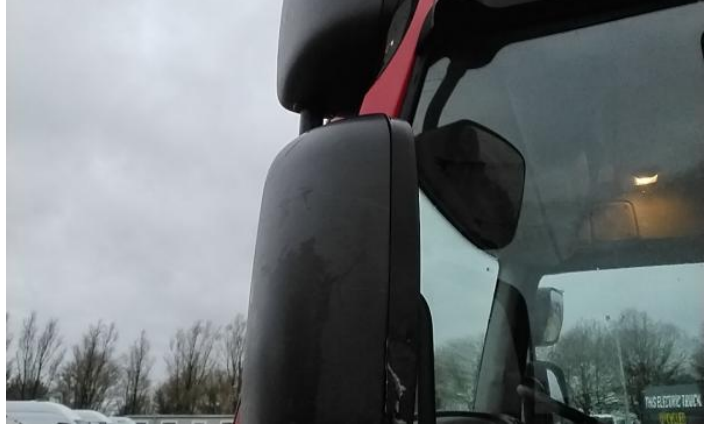
6: Door Mirror Assy nsf  
Broken  
Replace

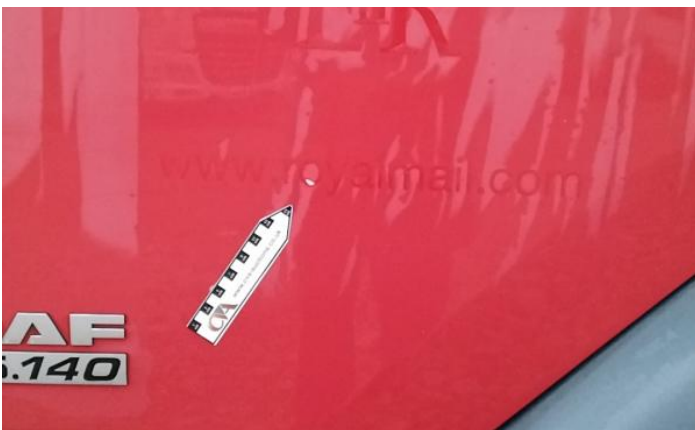
7: Door nsf  
Scratched  
UpTo 25mm Thru Paint

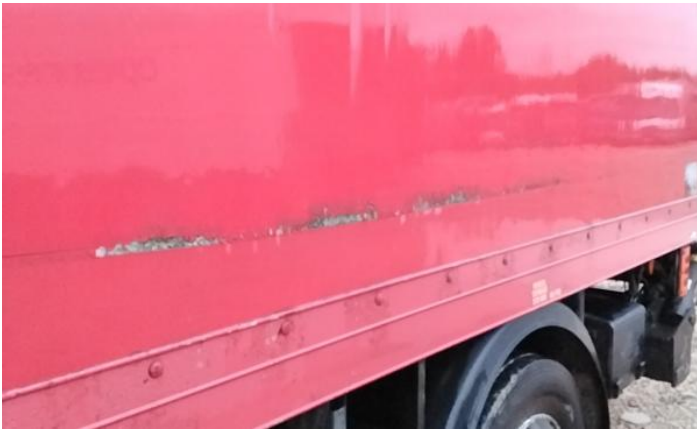
9: Qtr Panel nsr  
 Scratched  
 Over 25mm Thru Paint

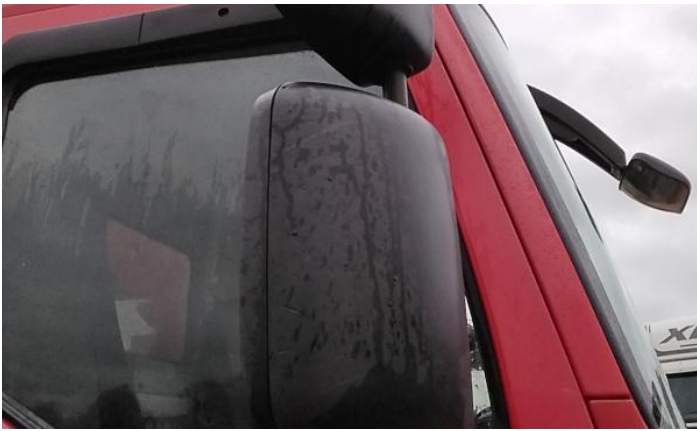
11: Door Mirror Assy osf  
 Scuffed (Unpainted)  
 Over 100mm

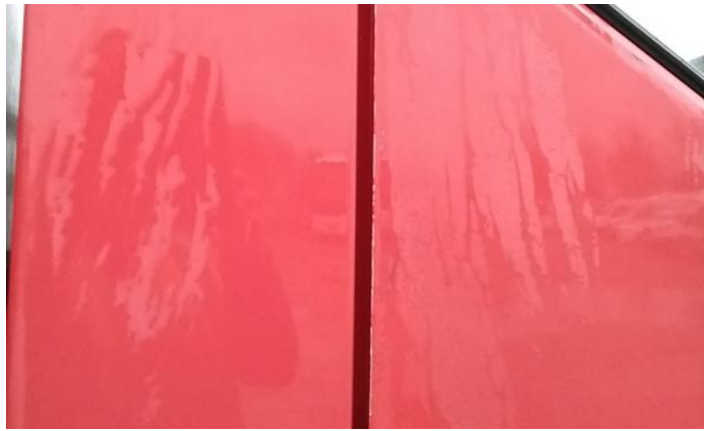
12: Door osf  
 Chipped  
 Edge Chip

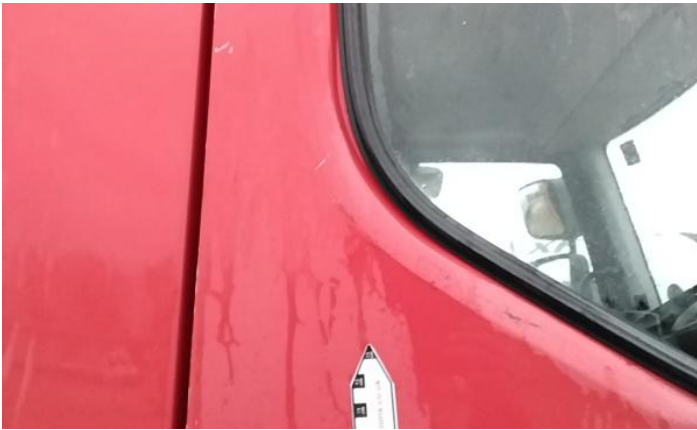
13: Door osf  
 Scratched  
 Over 25mm Thru Paint
